Manhole Inspection Summary

Manhole # S150O1017MH

Insp Date: **11/30/06 2:16 PM**

Location Address: **4802 NURTON AVE**

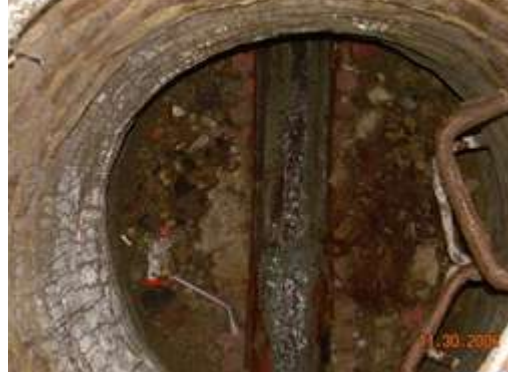
Top View

Evidence of surcharge - Bench debris.
Corroded steps.

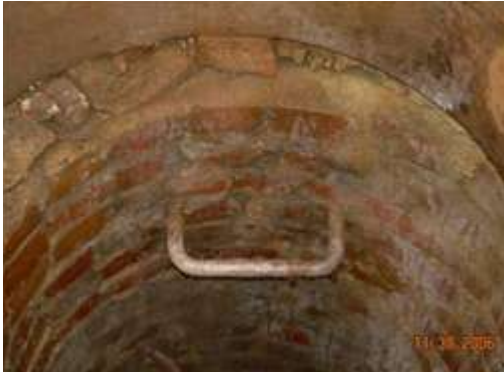
Defect

Frame Offset: **3** (in.) Condition: ☐ Sound ☐ Cracked ☒ **Leaks**

Condition: ☐ Sound ☐ Cracked ☐ Root Intrusion ☒ **Loose Brick** ☒ **Deteriorated**

Infiltration: ☐ None ☒ **Joint** ☐ Cracks ☒ **Mortar** ☐ Roots ☐ Wall

Frame leaks. Frame offset. Adjustment
deterioration, loose brick, and infiltration.

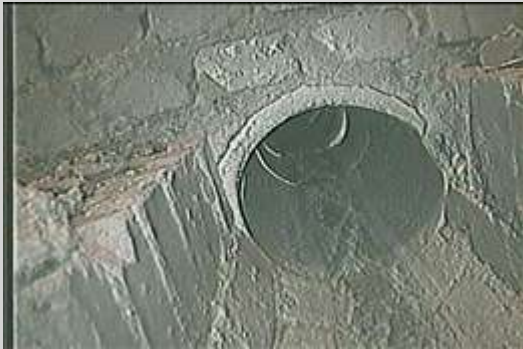
8 in. Circular Gravity Sewer Pipe Out @ 12 O'Clock

Pipe Material: **Clay** ☐ Pipe Lined

Invert Depth: **9.32** (ft.) Flow Characteristics: **Slow**

Infiltration: **None** Pipe Seal Cond: **Unknown**

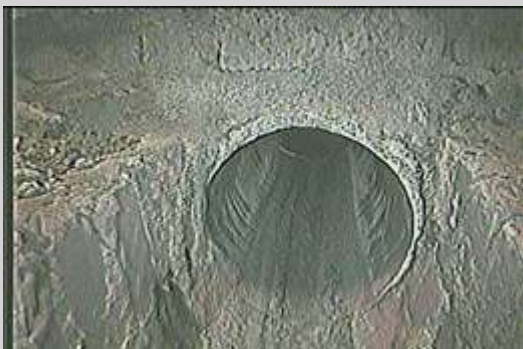
8 in. Circular Gravity Sewer Pipe In @ 6 O'Clock

Pipe Material: **Clay** ☐ Pipe Lined

Invert Depth: **8.95** (ft.) Flow Characteristics: **Slow**

Infiltration: **None** Pipe Seal Cond: **Unknown**
